TECHNICAL BULLETIN – TB257

WEATHER AND RELATED SITE EFFECTS ON LIQUID MEMBRANES

Date, Monday, 9 July 2018

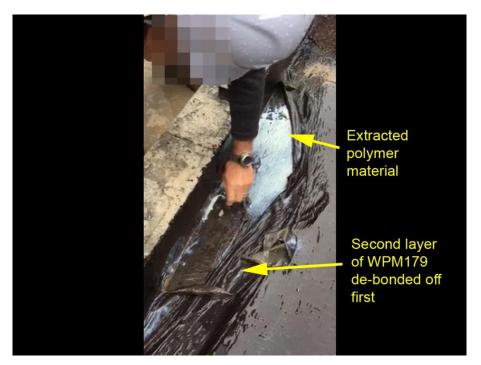
The effect of moisture falling onto uncured or partially cured membranes is variable. Whilst moisture cure urethanes can actually cure faster when dampened, epoxy resins can be inhibited because the water affects the amine catalyst. Water falling onto water borne membranes and cement containing ones, results in the material not drying, and if soft enough, being diluted and even washed away. Strong enough rain can produce physical damage to the surface such as cratering and pinholes, and leads to water being trapped in and under the membrane. Where water lands on the surface between coats of multiple coat systems, this normally disrupts the performance of second layer applied.

This problem can be seen in the below image, where the first and second layers of the membrane have not physically welded together because of water laying between them. The white material is hydrolysed and remobilised water borne polymer extracted from the second layer (so called re-emulsification) where it sat on the water covered first layer.

- Installation when rain has recently fallen, is currently falling, or is expected to fall soon has to be avoided where possible.
- Check the weather forecasts. Don't work in the rain. Take extra precautions after extreme rainfall events.
- Use tents or protection to cover areas to be worked on.
- Remove water that has accumulated from rain and allow the area to dry.
- Use fans or driers and ventilation to remove moisture and lower humidity.

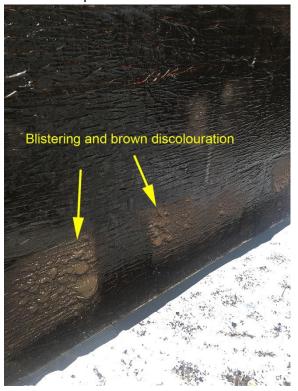
- a) Water vapour that is mobilised by sun exposure. The sun falling on the surface heats and causes the water to vaporise and generates a blister. When the surface cools back down, the water vapour coalesces and the blister subsides, however the membrane has been stretched and damaged regardless.
- b) Water filled blisters that arise from hydrostatic pressure. In this case we are usually referring to below grade areas where ground water can be present, or the situation where moisture can develop a head of pressure due to the height of the water column. A latter example being water saturated masonry walls, such as blockwork were the upper surfaces or top edge is exposed to rainfall which then penetrates and percolates down. An example is shown below.

This image shows water blisters in a membrane not designed to resist hydrostatic pressure, and water accumulating in the wall structure due to rainfall on the top.

In this type of situation, a membrane system (positive side waterproofing) requires a hydrostatic moisture barrier as the primer to suppress the moisture, or the substrate has to be left to dry out sufficiently.

- Use an appropriate moisture barrier as a membrane or membrane's primer.
- Make sure that below grade drainage is adequate.
- Prevent water getting into building elements in the first place (protection of parapets).
- Test for moisture content.
