TECHNICAL BULLETIN – TB084

WATER EFFECTS ON ARDEX ARDURAPID PRODUCTS

Date, Thursday, 9 October 2014

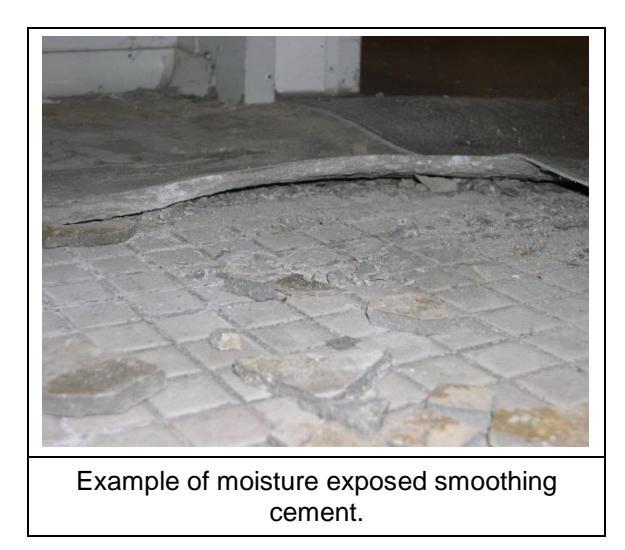
- 1. High concentrations of moisture over a period of time will firstly soften & damage the acrylic/latex based floor covering adhesive, and result in bubbling or lifting of the floor covering. Carpets can develop mould and bad smells, and directly stuck timber can swell and deform.
- 2. The continuing high concentration of moisture/water in the ARDEX ARDURAPID smoothing cement may permanently damage the matrix also. This is evidenced by the development of white spots, crystalline growths, warping and internal delamination.
