TECHNICAL BULLETIN – TB128

REINSTATEMENT OF CONCRETE PIERS IN TIDAL ZONES ABOVE LWL

1 AUGUST 2013

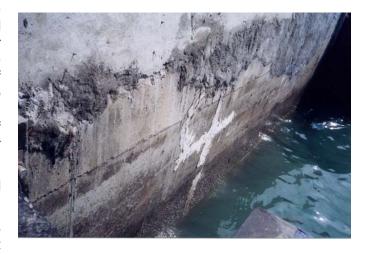
Structural or potentially structural cracks, honeycombed pockets, holes and faulty or deteriorated construction joints have always existed on this concrete pier, seawall facing the sea. The structure is in a highly variable tidal zone and the texture of concrete is generally very rough allowing maximum impact damage to be caused by the incoming tides.

Years of physical attack from wave and general sea movements and chemical attack from the salt water has damaged the integrity of the concrete, and the neutralisation of the alkaline passive nature of the concrete protecting the reinforcing steel has resulted in the corrosion of the reinforced steel, causing further physical damage to the concrete.

All surfaces were high pressure turbo water blasted to remove all loose and structurally unsound concrete.

Exposed reinforcing steel was thoroughly cleaned by hand wire brushing to be free from all corrosion products. Steel that had suffered a metal loss in excess of 40% was cut out and replaced. The new steel sections were tied into the old steel.

The exposed reinforcing steel was protected by coating with an epoxy cement slurry and a bonding bridge of the same material applied over the concrete areas to be repaired to produce a structural bond between the repair mortar and the original concrete. The slurry coat was prepared by mixing equal volumes of ARDEX WPM256 HydrEpoxy and cement with a small quantity of sand to form a thick brushable slurry consistency.

A high strength concrete repair mortar was prepared be mixing equal volumes of ARDEX WPM256 HydrEpoxy and cement with 2 to 3 volumes of sand. The repair mortar must be placed while the slurry coating remains wet. Damaged areas of concrete were repaired taking care to work the mortar in behind the reinforcing steel and worked into the old concrete.

The slurry coating and repair mortar were progressively installed down the structure with the receding tide and ceased just before the tide reached LWL (low water level). This allowed initial set to occur during the turn of the tide and the epoxy/cement mortar continued to cure underwater.

The entire surface is then treated by coating with ARDEX WPM300 HydrEpoxy waterproof membrane to prevent the ingress of water and chloride ions into the concrete. A primer/bond coat was first applied to achieve maximum bond strength to the substrate
